## **MEMORANDUM**

Wood Creek HOA

RE: Column Replacement Update

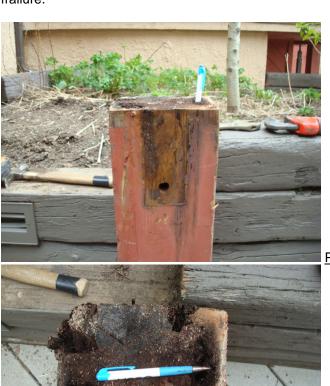
Photo 4

After the existing columns were the removed the following picture below were taken to show the amount of rotting that had begun at the centers of the columns. The pen shown in photo 4 was able to easily be stuck into the base of the column. Over time what would have happened is that rotting would have made its way towards the outside of the column and the base of the column would have experienced crushing frailure.
